Heavy Ion Single Event Effects Test Results for Agere LSP2916 16-Channel, High Voltage Driver (MEMS)

Scott Kniffin¹, Zoran Kahric², and Hak Kim³

TEST DATE: December 20-21, 2001 REPORT DATE: January 10, 2002

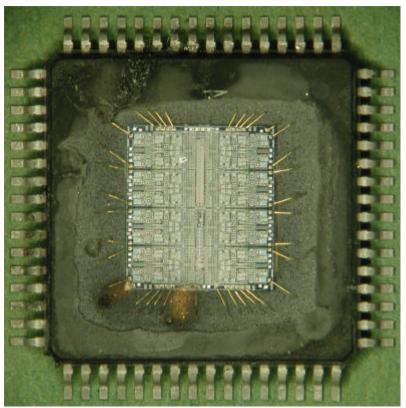
The device exhibited what appears to be a destructive SEGR at an LET of <26.6 MeVcm²/mg (Ni-58 at normal incidence). It should be noted that there is a gap in LETs tested to do availability of beam, therefore the actual limiting LET may be slightly lower. The SEGR rendered the entire device non-functional due to the partial vaporization of the V_{LP} bond wire (A type, -33V/V gain devices) or the complete vaporization of the V_{LP} , V_{HN} and GND bond wires. See Figures 2 and 3 for views of DUT 2 (B type, -66V/V gain devices). When the SEGR occurred, in all cases, a spark was visible on the test vacuum chamber CCTV monitor. In the case of DUT 11, the first run with Ni probably caused a momentary melt that self-healed. The subsequent run caused a permanent failure. See Table 1 for a list of exposures and run information.

Figure 2: Full view of DUT 2 with vaporized bond wires.

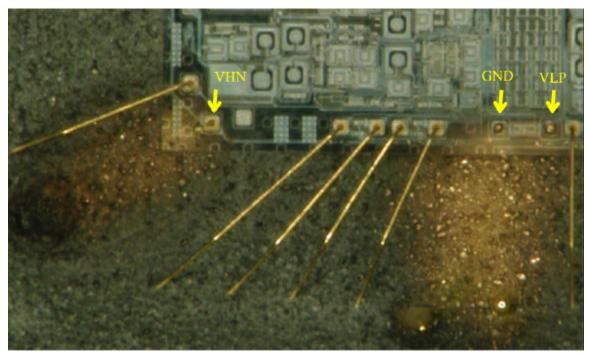
Figure 3: Detail view of DUT 2 with vaporized bond wires. Note that there were additional melt points along the traces of all three affected pins that are not visible in this photograph.
